# MANDATORY SERVICE BULLETIN

Service Bulletin No. 525A  
(Supersedes Service Bulletin No. 525)  
Engineering Aspects are  
FAA Approved

**SUBJECT:** Inspection of High Pressure Fuel Pump P/N LW-15473

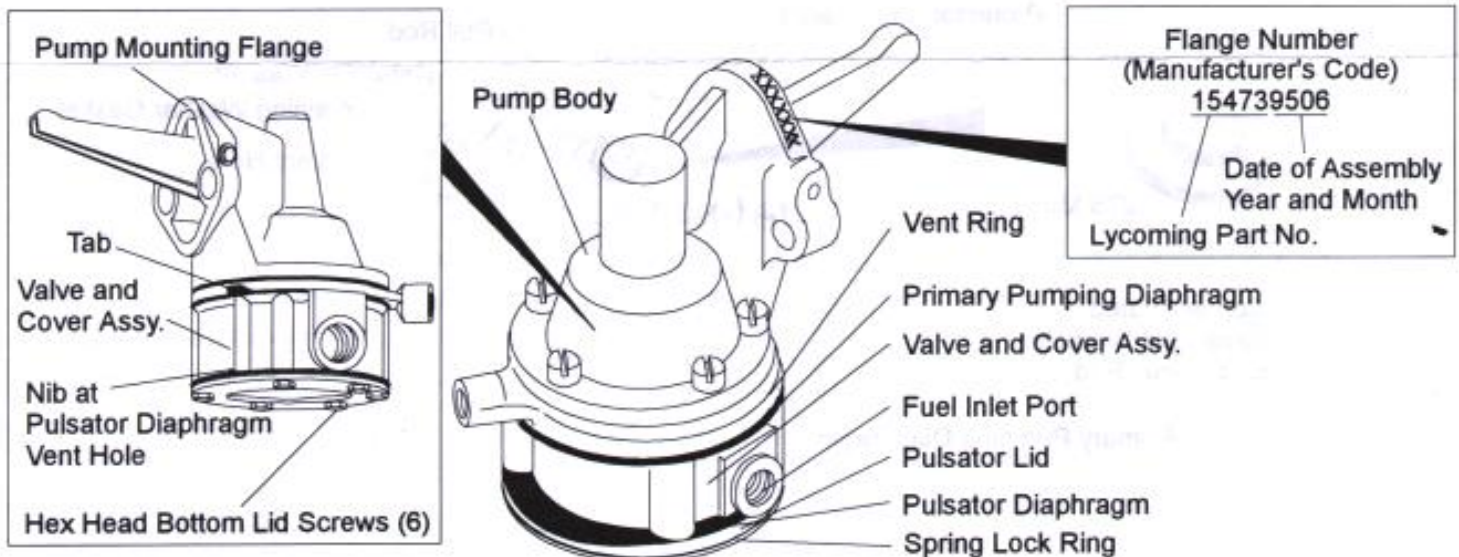
Figure 1.

**If your Textron Lycoming engine has a P/N LW-15473 high pressure fuel pump installed, with flange number (manufacturer's code) scribed on the pump of 154739506, 154739507 or 154739510, it must be inspected before further flight of your aircraft.**

11. To identify that this examination was accomplished on the pump assembly, mark an "A" by metal stamp or scribe on the pump mounting flange immediately before the flange number (manufacturer's code). (Refer to Figure 1). If necessary due to space constraints, the "A" may be located just above the rocker shaft pin. An entry in the engine and/or aircraft log book should also be made.

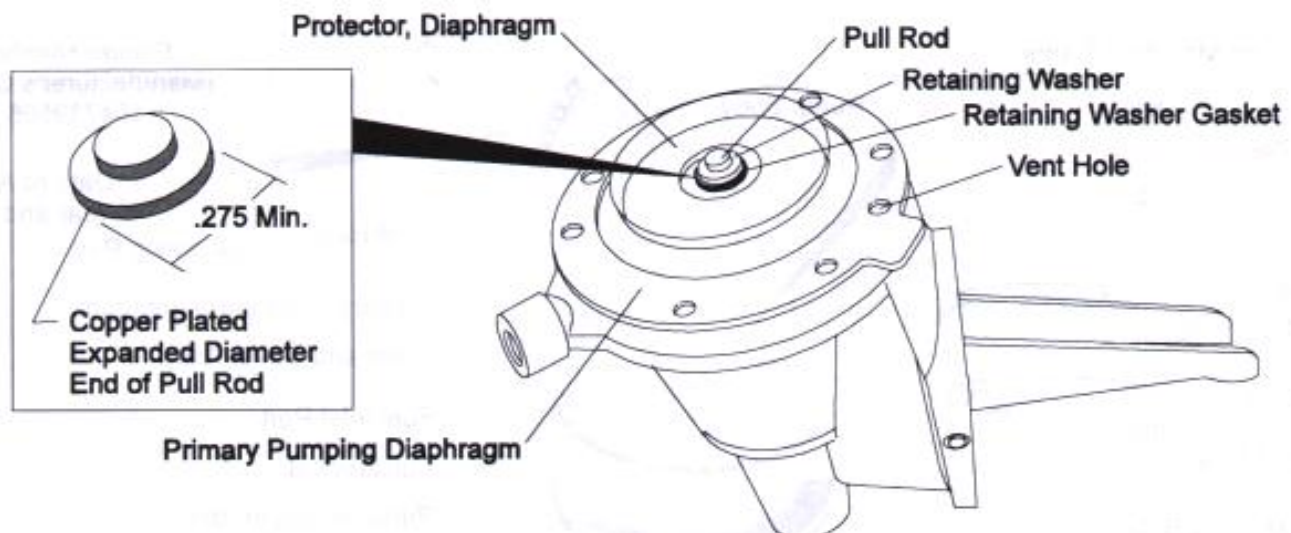
Figure 2.

Textron Lycoming has determined that a number of high pressure fuel pumps, P/N LW-15473, manufactured between June and October of 1995 may have manufacturing defects that may result in engine stoppage. Several instances have occurred where the retaining washer gasket has separated from the pull rod assembly and lodged in the pump outlet valve restricting fuel flow.

4. Visually inspect for proper location and retention of the retaining washer gasket in the pull rod/diaphragm assembly. (Refer to Figure 2.) If the gasket is not found between the retaining washer and diaphragm protector or it protrudes more than 1/16 inch beyond the retaining washer at any point, the pump is unserviceable and must be replaced.

5. Using vernier or dial calipers, measure the diameter of the larger copper plated expanded end of the pull rod immediately next to the retaining washer (see Figure 2). If this diameter measures less than .275 inches, the pump is unserviceable and must be replaced.
