## Airworthiness Directive

Amendment 39-5338; AD **72-06-05** R2

Airworthiness Directives; MARVEL SCHEBLER (Facet Aerospace Products Company): Applies to Models MA-3, MA-3A, MA3-PA, MA-3SPA, MA4-SPA, MA4-5, MA4-5AA, MA-5, MA-5AA, MA-6AA and HA-6 Carburetors

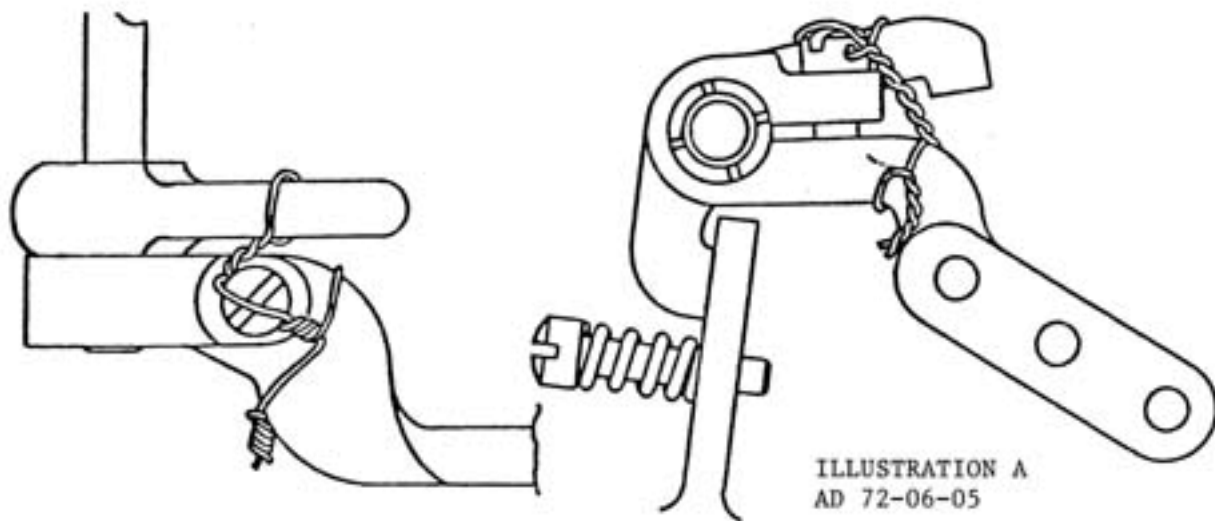
To prevent looseness or separation of the throttle arm, accomplish the following or any equivalent procedure approved by the Manager, New York Aircraft Certification Office, FAA, New England Region.

- (2) Inspect the throttle arm on Marvel Schebler MA-3, MA-3A, MA-3PA, MA3-SPA, and MA-4SPA carburetors to determine whether it has a spotfaced or milled flat for the head of the clamping screw. Replace any arm having a milled flat with one having a spotfaced flat. If not already installed, install a Marvel Schebler P/N A15-493 clamping screw (No. 10-24 x 5/8 slotted drilled fillister head) in the throttle arm. Torque the clamping screw to 20-28 in.-lb. and inspect the slot in the end of the arm for clearance. If the slot has closed so that no clearance remains, replace the arm and retorque to the above specifications. After the specified torque is established safety wire the throttle arm and clamping screw to the throttle stop as shown in Illustration A.
